CASE STUDY – AUGUST 2023

Location – Western Finland

9 turbine Wind Farm Site

PROJECT OVERVIEW

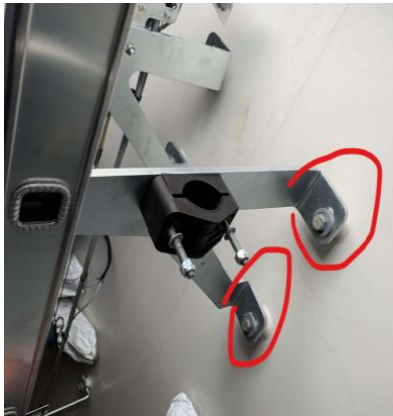
<p><u>Defect and issue</u></p> <p>Following erection of the 9 x turbines in Western Finland, the client discovered (according to the technical documents) that the TIG dressing on all the welded sockets (fixing points for the ladder, flange and miscellaneous units) was not carried out by the construction company, and did not reach the required NC100 standard on the welds.</p> <p>There were 372 sockets per turbine welded to the turbine skin / wall.</p>	<p><i>Ladder socket fixings</i></p>

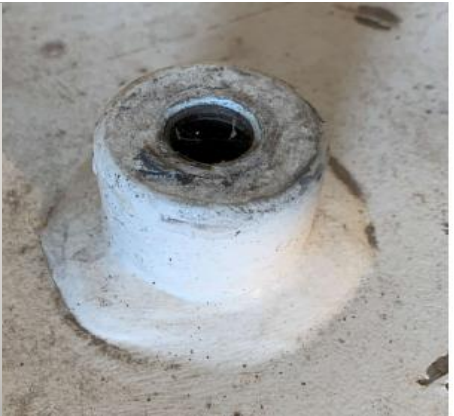
<p><i>Defective socket</i></p>

<p><u>Solution</u></p> <p>So to achieve the required welding spec (in-situ), and without the requirement to grind out the welds conventionally and then re-weld (due to large safety factors of the towers already being built), it was decided to use a procedure for welded structures called High Frequency Mechanical Impact Treatment (HFMI).</p> <p>This involved using a special peening tool with end pin that peened the full toe area of the socket weld, thus improving the fatigue weld strength and service life, but more importantly, achieving the welding standards required.</p>	<p><i>HFMI tool</i></p>
