CASE STUDY

Location – Western Sweden

Wind Farm Site of 114 turbines

Defect and issue

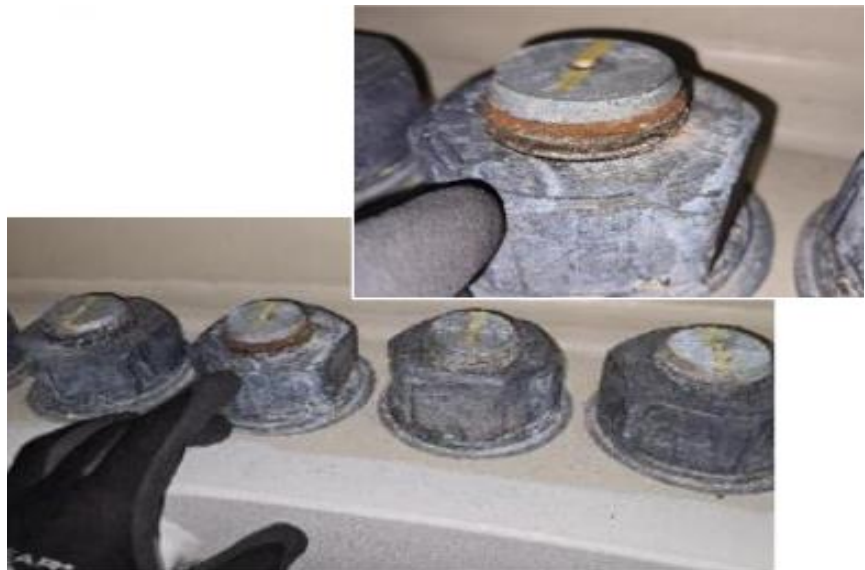
It was found that during construction of each tower, the work had often been carried out in extremely low temperatures. In addition, questions around both storage and handling in these conditions may have impacted the bolt quality. There was also “white corrosion” found on tower bolts.

Evidence of “White Corrosion”

From this analysis, it was decided that all fasteners on every flange section should be replaced.

This resulted in the exchange of approx. 62,000 + nuts & bolts (approx. 540 per WTG) on 113 standing WTGs.

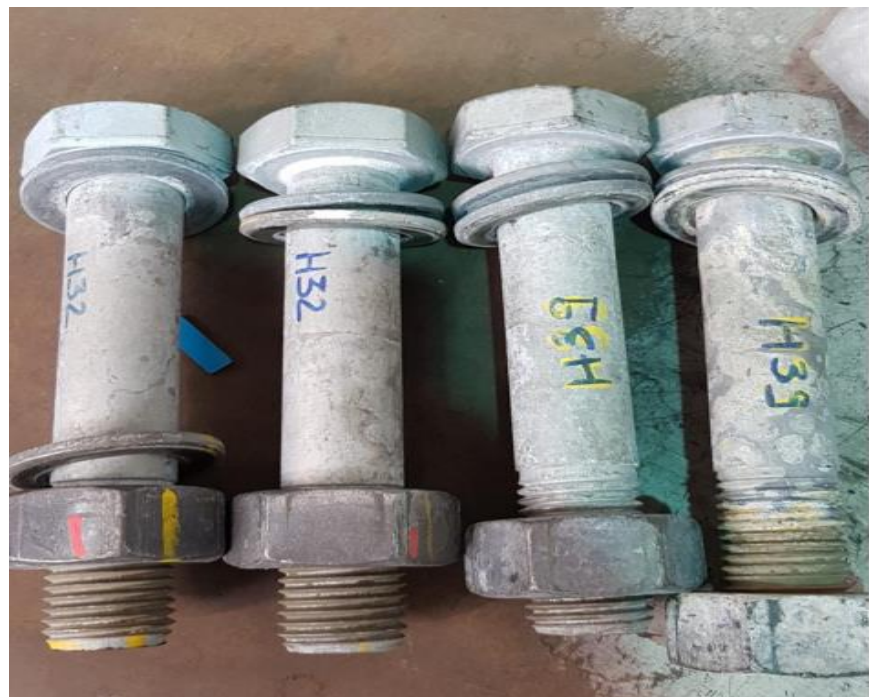
Examples of the removed bolt sets

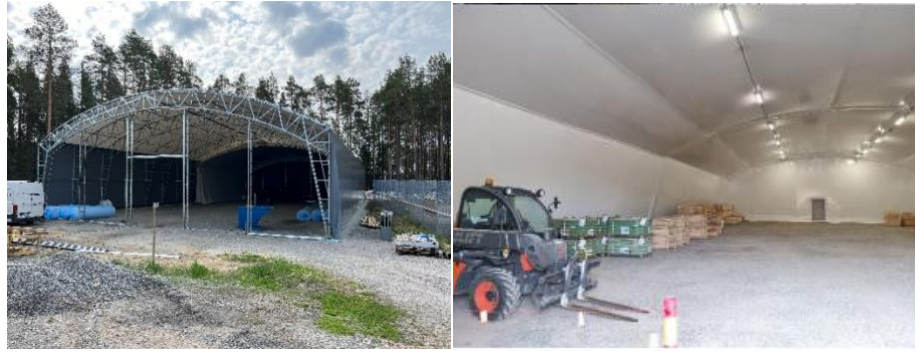
The client then looked to order and free issue the 62,000 fasteners needed to carry out the scope. To maintain a good storage environment for the bolts & nuts, a tent was constructed at the compound, large enough for a fork lift truck to easily manoeuvre crates of fasteners into vans for transport to the WTGs.

The tent was also heated to maintain correct storage of the fasteners.

TENT construction and finished article

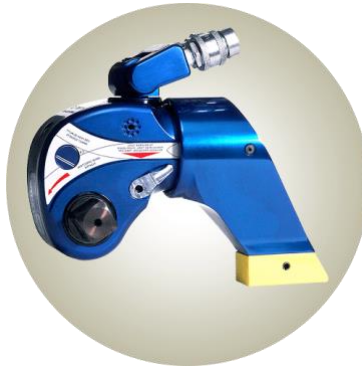
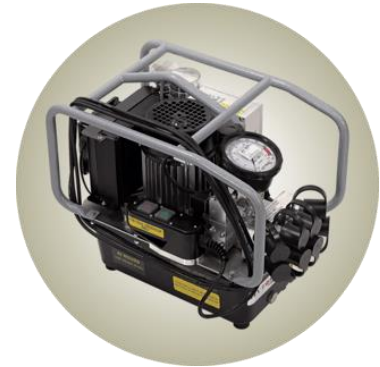
We sourced the correct tooling required for the work which resulted in 3 x sizes of torquing machines, together with associated pumps and all relative sockets.

Torquing Tooling
