CASE STUDY – AUGUST 2023

Location – Western Finland

9 turbine Wind Farm Site

PROJECT OVERVIEW

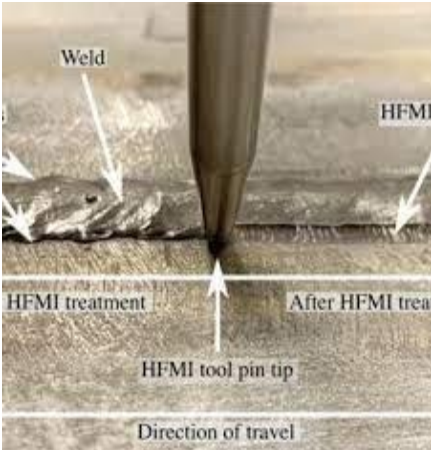
<p><i>Peening illustration</i></p>

<p><u>Solution</u></p> <p>So to achieve the required welding spec (in-situ), and without the requirement to grind out the welds conventionally and then re-weld (due to large safety factors of the towers already being built), it was decided to use a procedure for welded structures called High Frequency Mechanical Impact Treatment (HFMI).</p> <p>This involved using a special peening tool with end pin that peened the full toe area of the socket weld, thus improving the fatigue weld strength and service life, but more importantly, achieving the welding standards required.</p>	<p><i>HFMI tool</i></p>
